Rehabilitation Techniques for Stripped Asphalt Pavements

Final Report

STATE OF MONTANA
DEPARTMENT OF TRANSPORTATION
RESEARCH AND DEVELOPMENT PROGRAM

December 2002

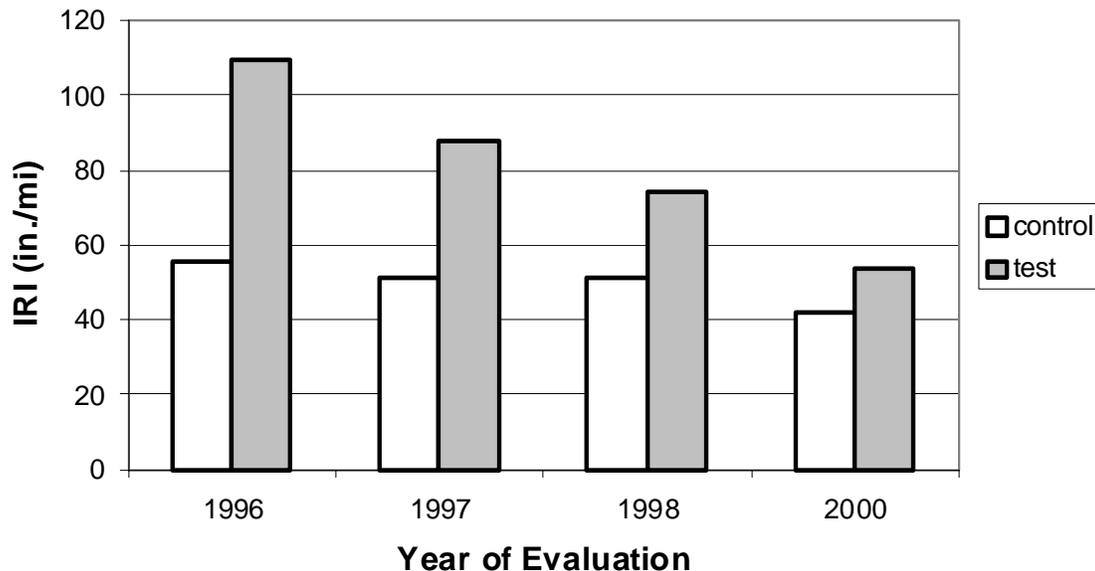
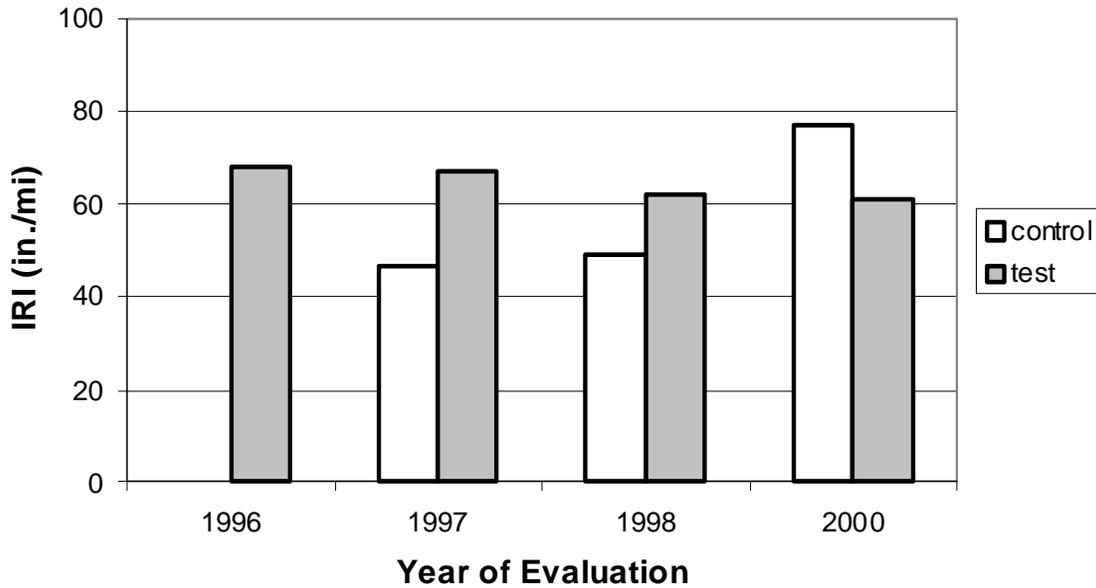
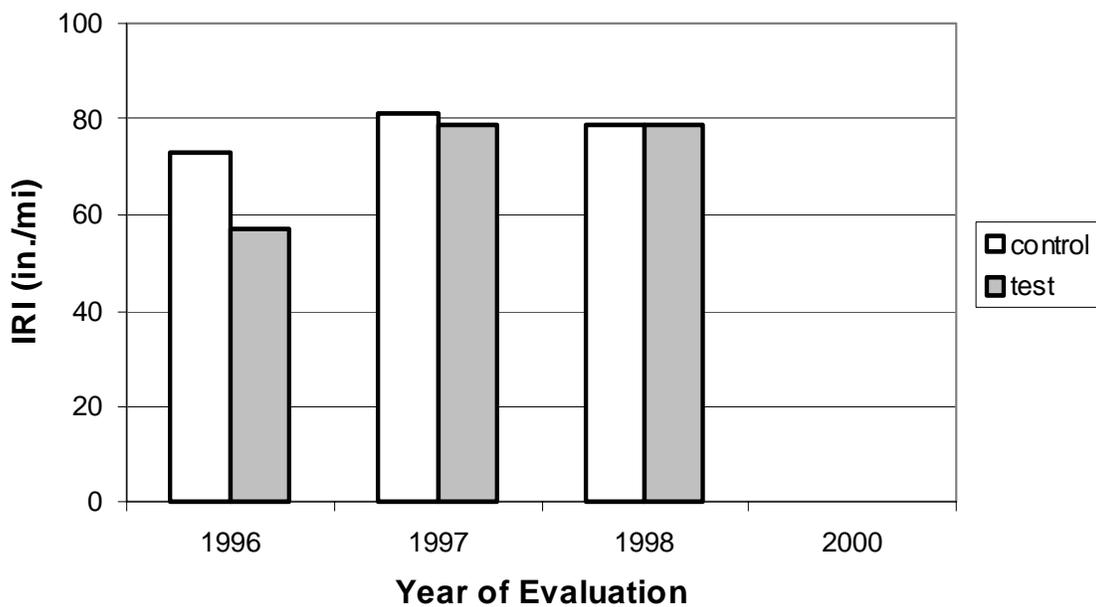
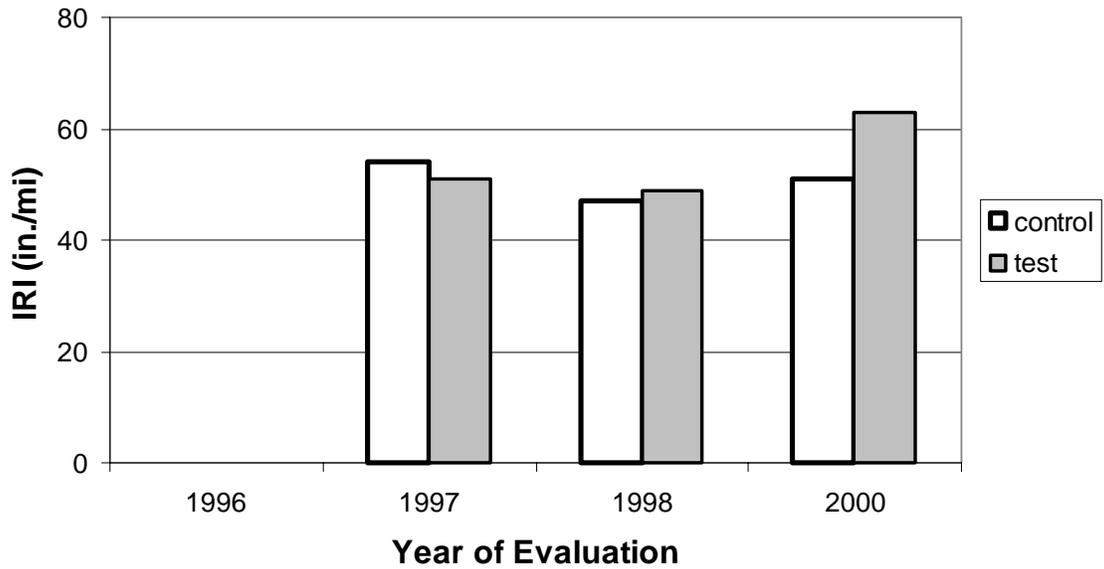
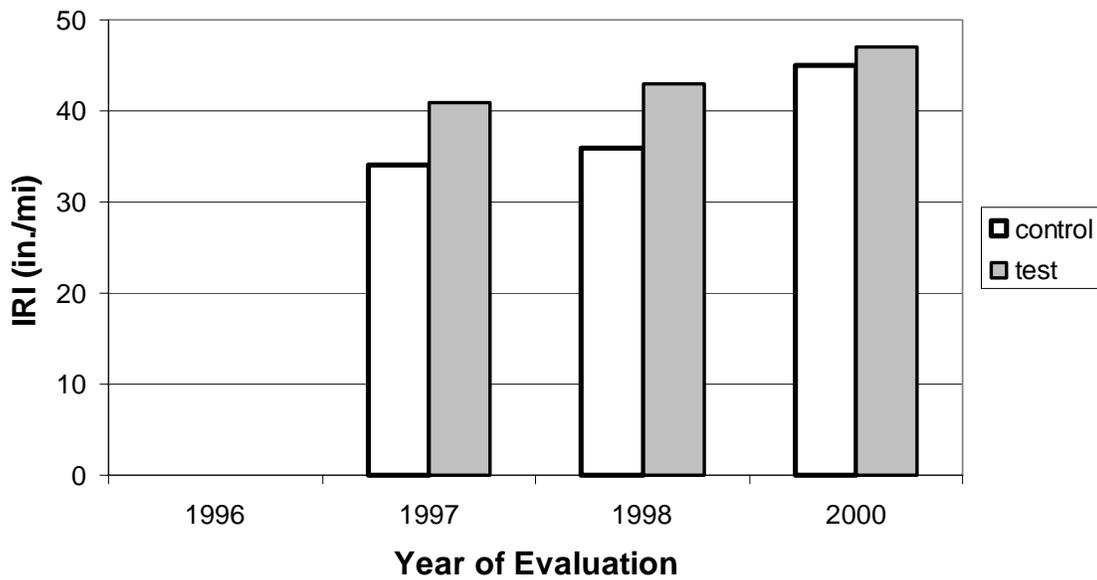
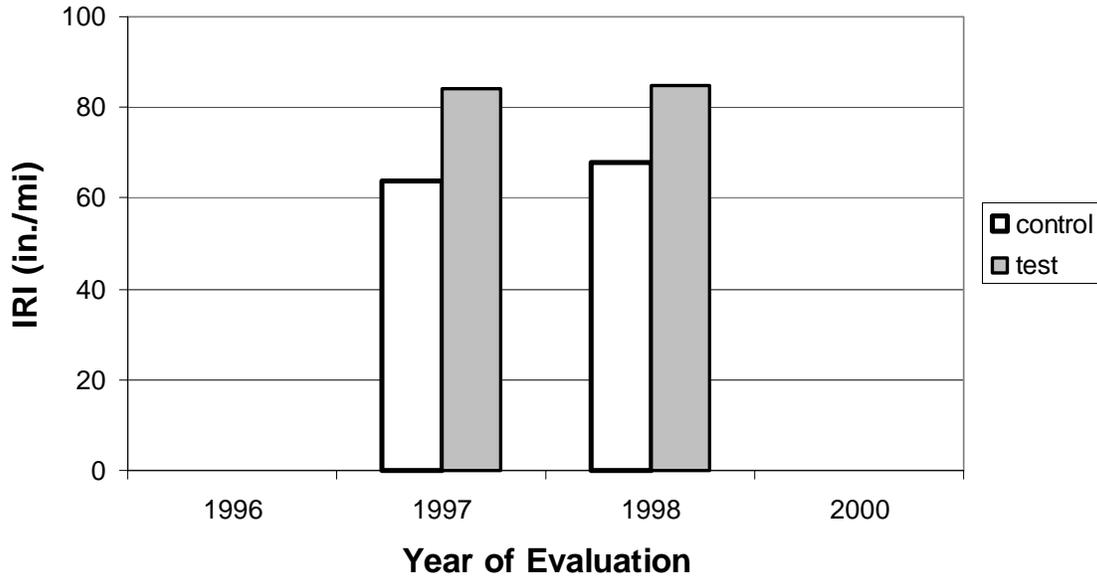
The experimental pavement sections began their service with roughness values (IRI) of approximately 40 to 100 inches per mile (see Figures 28 through 33 and Appendix D), which correspond to MDT qualitative rankings of good to fair (see Table 9). The IRI, soon after construction, were similar for the control and test sections at Rocky Canyon, Lincoln Road-Sieben, and Custer County Line West (see Figures 30 through 32). The IRI for these sites generally increased with time, slightly more so for the test sections than the control sections. At Bearmouth-Drummond (Westbound) and Tarkio-East, the IRI were higher for the test sections than for the control sections on all evaluation dates (see Figures 28 and 33). At Bearmouth-Drummond (Eastbound), the test section had a higher IRI in 1997, but by 2000 the control section had a higher IRI (see Figure 29).

Figure 28. International Roughness Index at Bearmouth Drummond, Westbound Lane

Figure 29. International Roughness Index at Bearmouth Drummond, Eastbound Lane

Figure 30. International Roughness Index at Rocky Canyon

Figure 31. International Roughness Index at Lincoln Road

Figure 32. International Roughness Index at Custer County Line

Figure 33. International Roughness Index at Tarkio East

In summary, the control sections were generally smoother than the test sections. The control sections involved more milling and thicker placements of new material, which should promote a smoother product, relative to the thin milling and overlay used for test sections. However, during the last year of evaluations (year 2000), there was no pavement section with an IRI greater than approximately 80 in./mi., which is considered by MDT to be borderline good to fair.

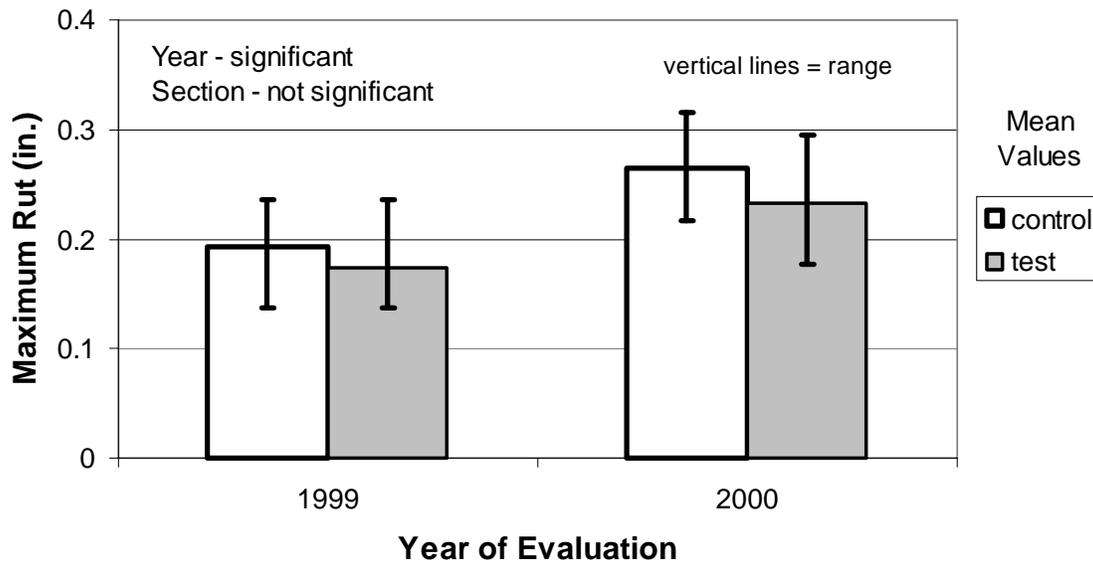
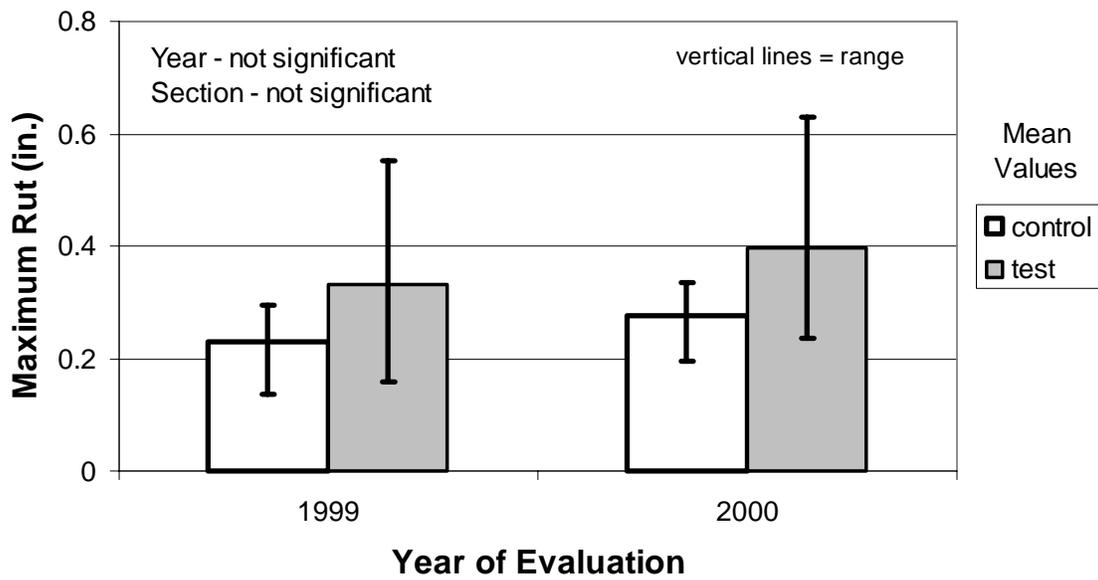
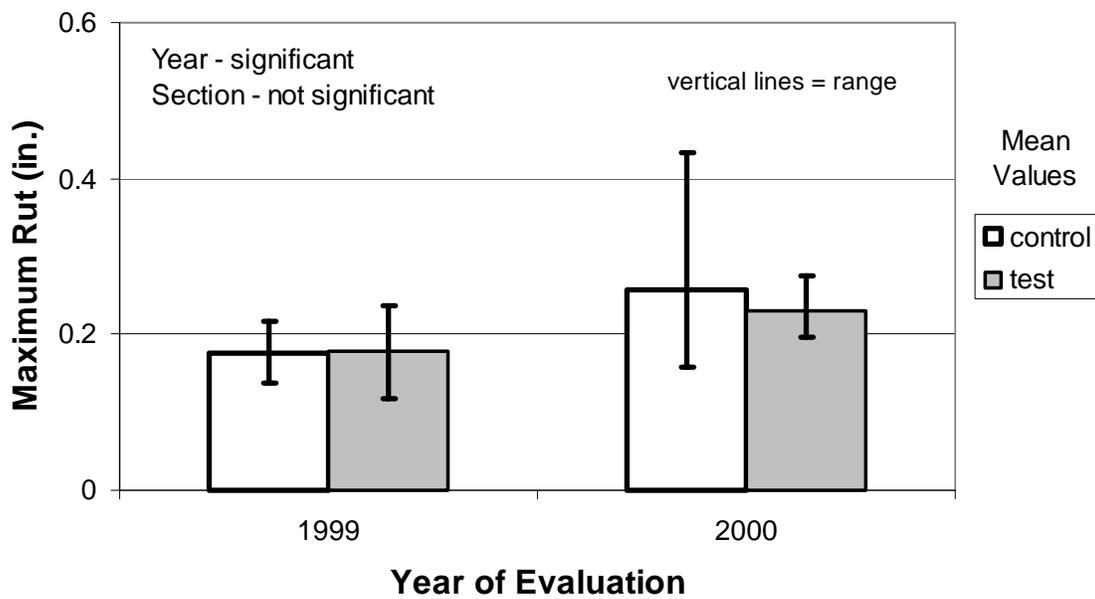
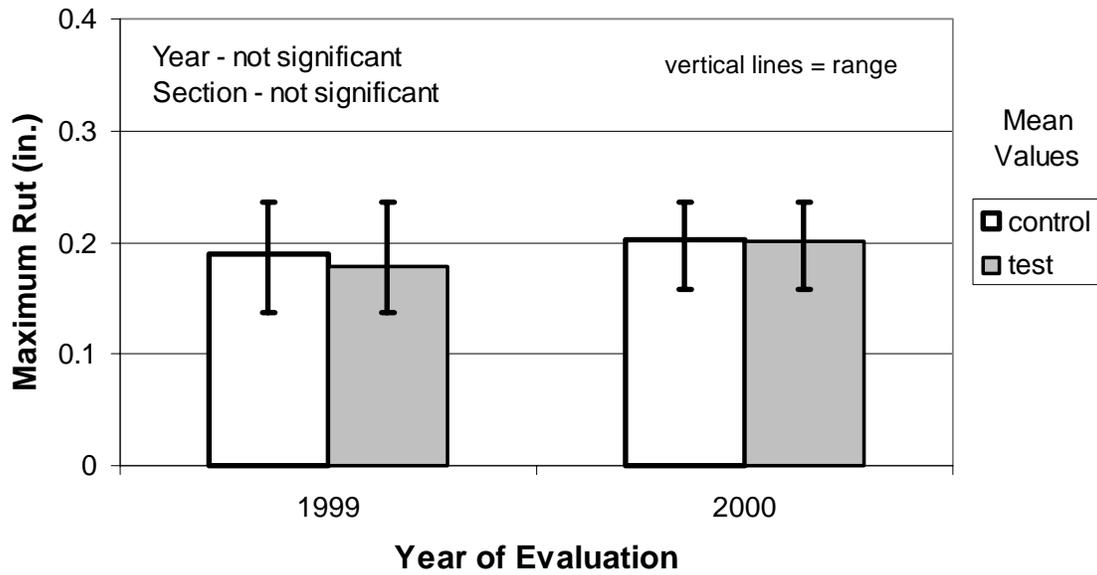
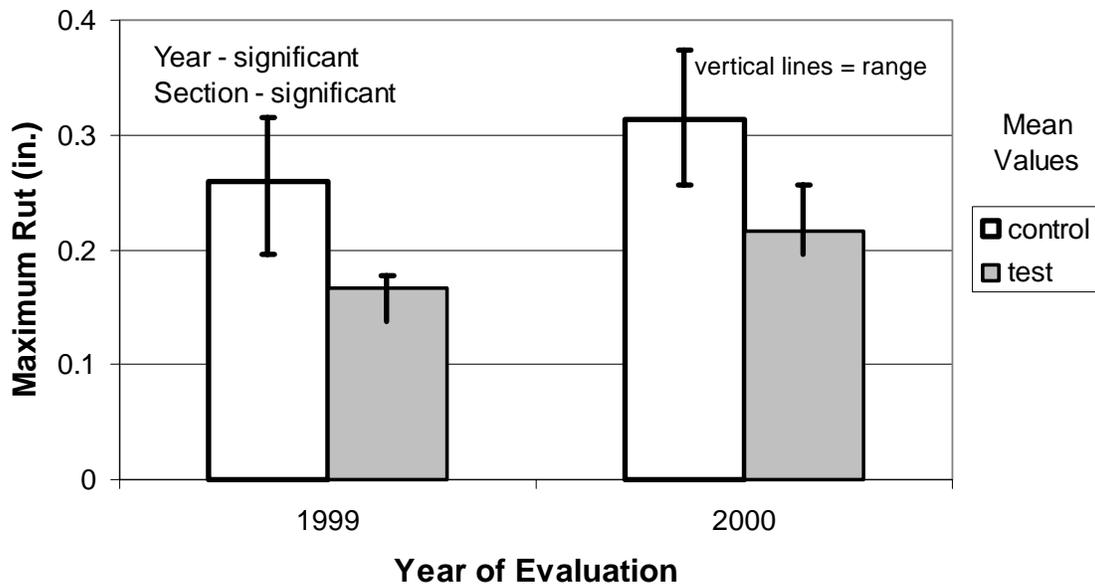
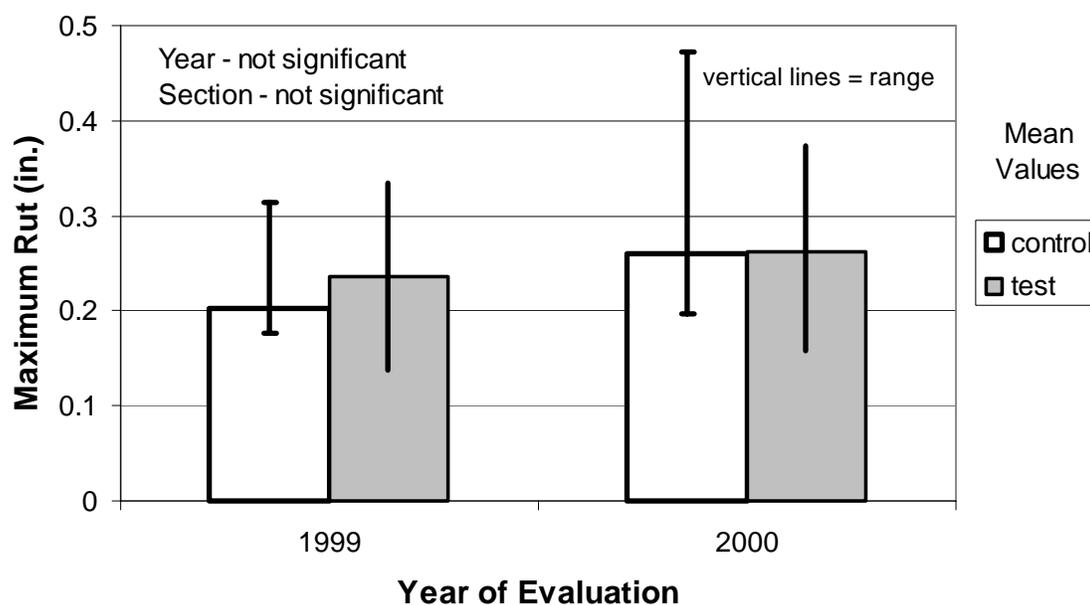
analysis of variance. The effect of year (i.e. date of evaluation) on rutting was significant at one-half the sites: Bearmouth Drummond Westbound, Rocky Canyon, and Custer County (see Figures 34, 36, and 38). In each of these cases, rutting increased significantly from 1999 to 2000. At the other sites, rutting increased, but variability in the rut measurements was high relative to the change in mean values (see Figures 35, 37, and 39). The difference between control and test section was significant only for Custer County (Figure 38). In this case, the test section rutted less than the control. By the year 2000, Bearmouth-Drummond (Westbound) had the most rutting (up to about 0.4 in.) and Lincoln Road had the least rutting (up to about 0.2 in.).

Figure 34. Rutting (Rainhart Profilograph) at Bearmouth Drummond, Westbound Lane

Figure 35. Rutting (Rainhart Profilograph) at Bearmouth Drummond, Eastbound Lane

Figure 36. Rutting (Rainhart Profilograph) at Rocky Canyon

Figure 37. Rutting (Rainhart Profilograph) at Lincoln Road

Figure 38. Rutting (Rainhart Profilograph) at Custer County Line

Figure 39. Rutting (Rainhart Profilograph) at Tarkio East

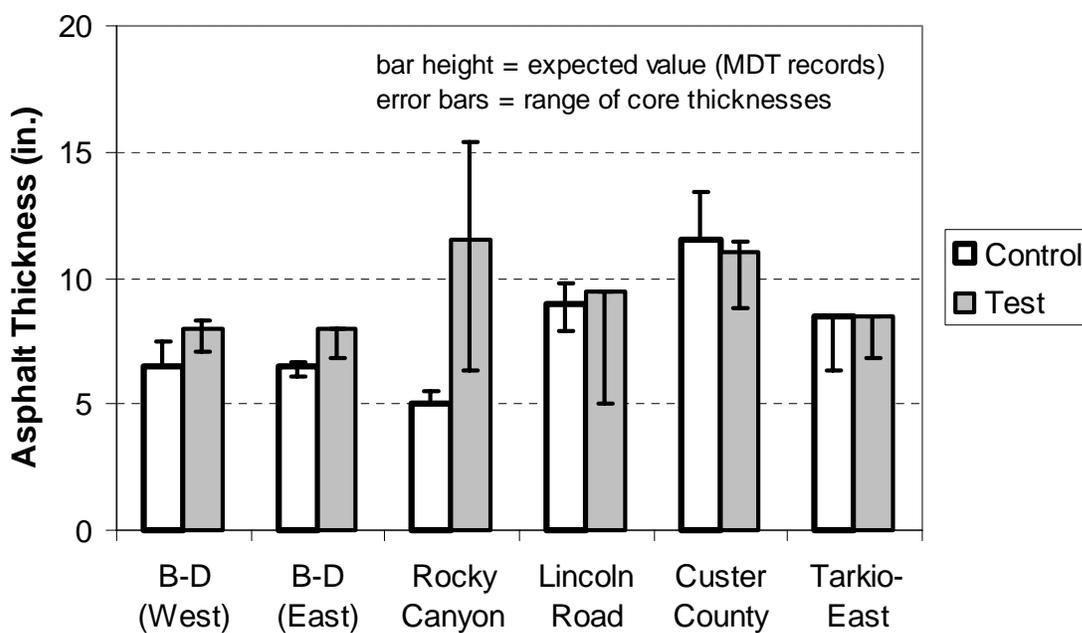
Figure 40. Comparison Between Core Thicknesses and MDT Records

The differences between control and test section thicknesses at individual sites (Figure 40) were to be expected. Relative to the test sections, the control sections received deeper

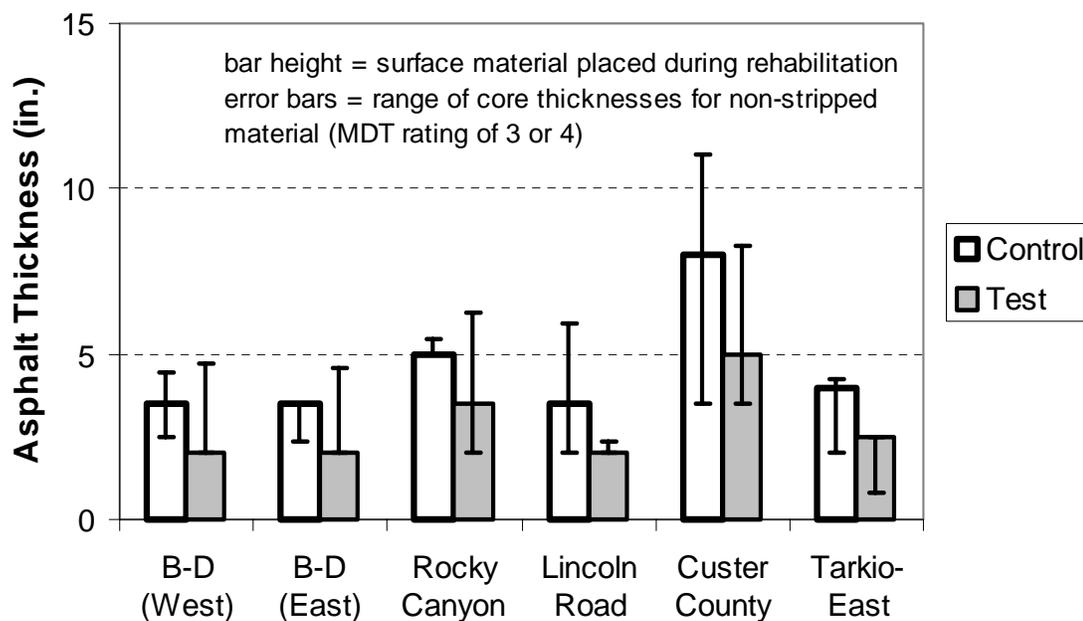
Figure 41. Thickness of Non-stripped Asphalt Concrete Near the Pavement Surface

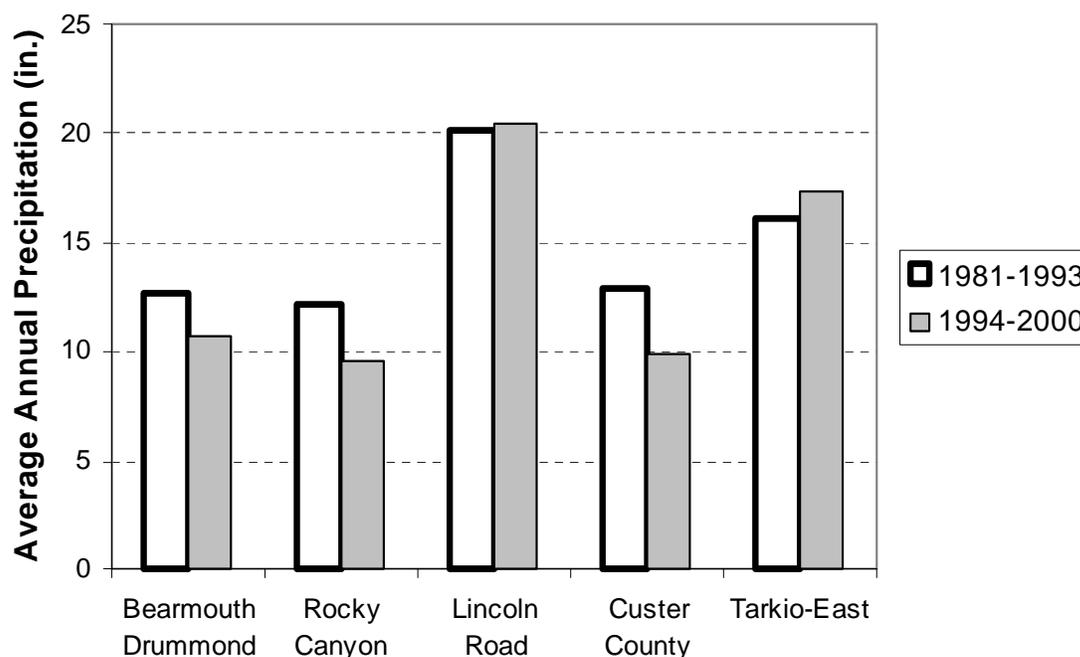
Figure 43. Average Annual Precipitation Near Test Sites During the Experiment

Therefore, it would appear that lack of normal moisture should not have skewed the research results at Tarkio or Lincoln Road. However, lower-than-normal rainfall is a factor that should be taken under consideration when analyzing the results for Bearmouth Drummond, Rocky Canyon, and Custer County. In summary, it does not appear that the reduced precipitation in Montana in recent years should have a substantial effect on this asphalt stripping experiment.
